## Case Study

# Rochdale Exchange Car Park

### Project: Rochdale Exchange Car Park

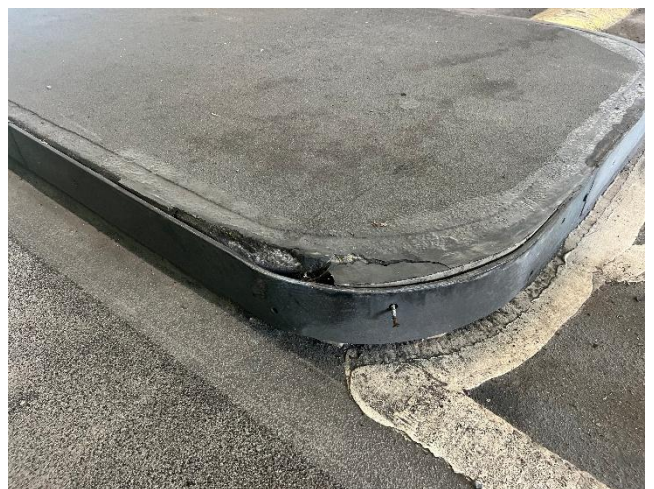
Situated above Rochdale Exchange Shopping Centre, this busy car park was suffering from damaged asphalt. Car tyres had caused numerous dips on the surface and the curbs were also in need of repair.

These failings demanded a high-performance waterproofing and surfacing system, which could be installed while the car park remained open to the public.
