# The Plaza

## Project: The Plaza, Wokingham

Five levels of a multifunctional car park have been refurbished using WestWood Liquid Technologies' products, requiring meticulous planning.

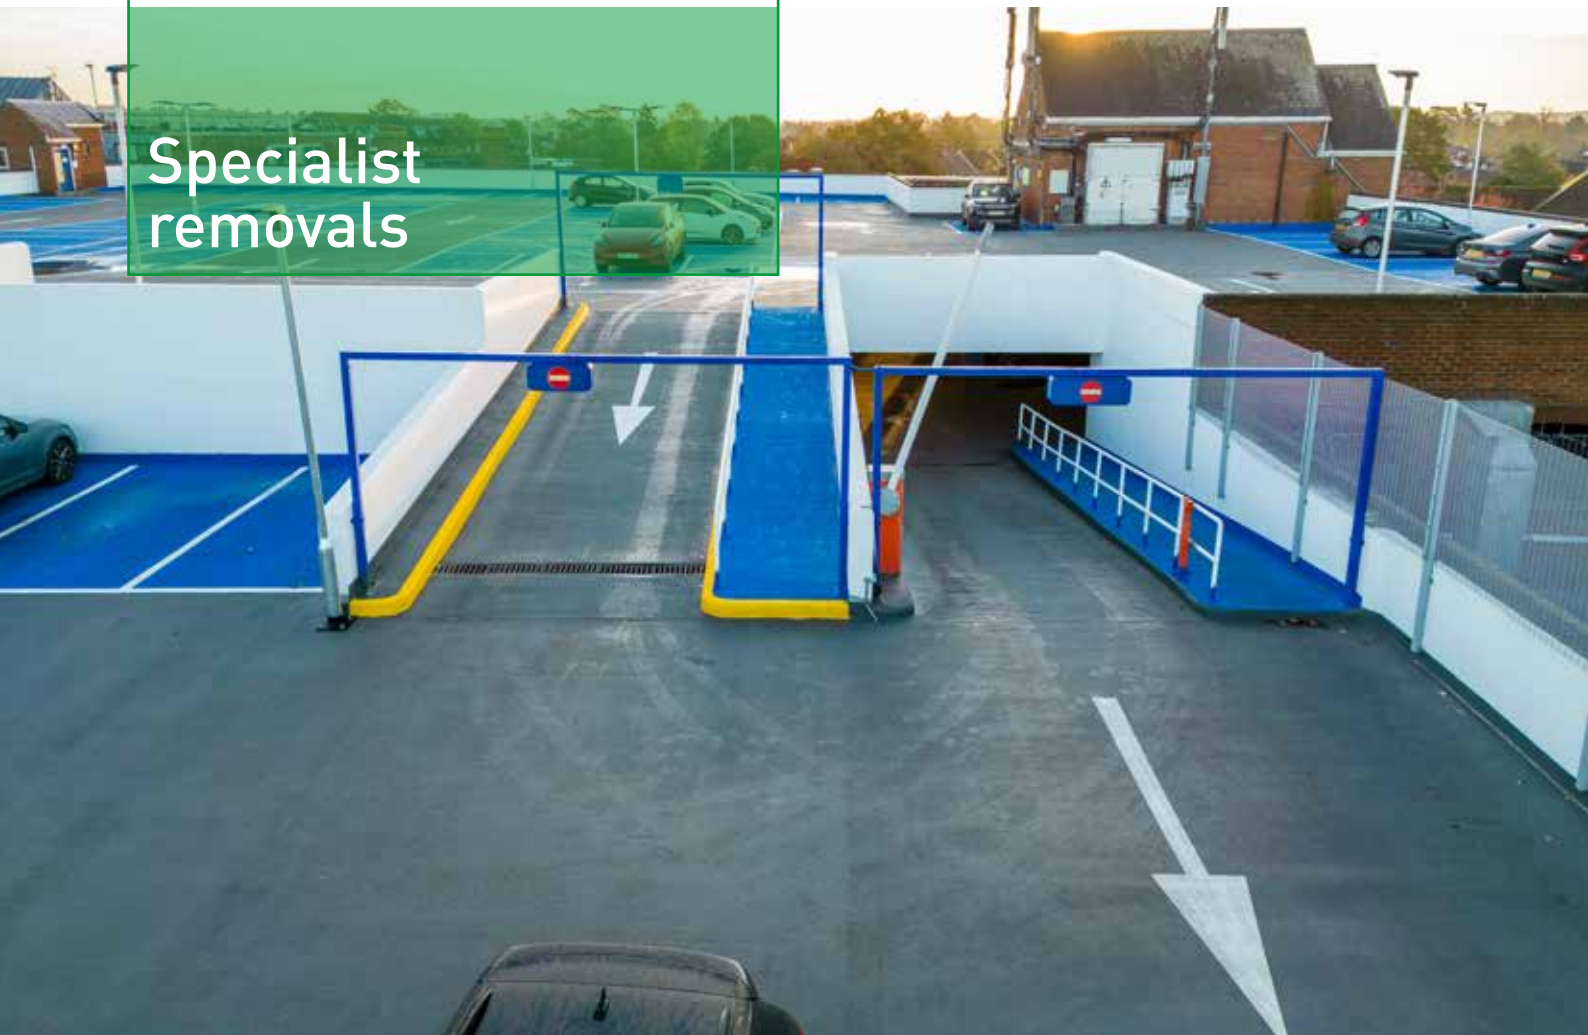
To address **concrete substrate** issues, the car park roof deck underwent significant repairs. The existing waterproofing system had failed and was **expertly removed** using a specialised 'ride on' planing plant, designed for multi-storey car parks. This method ensured complete removal of the coating without damaging the concrete roof slab.

Operating in a **live environment** required additional considerations, including noise and dust suppression. Water drums on the plant and water bowzers were used to dampen the deck, suppressing dust during operation. The disposed tonnes of failed coating were carefully managed using dedicated skips from Cemplas's waste management partners to avoid mixing with recyclable materials.

More than 200 sq. m (25 tonnes) of defective concrete was also removed and **responsibly disposed** of in a dedicated skip for concrete recycling. The transportation of both coating and concrete to the secure site compound was executed with forklifts and tipping skips, operated by trained drivers and banksman to prioritise the safety of car park patrons.

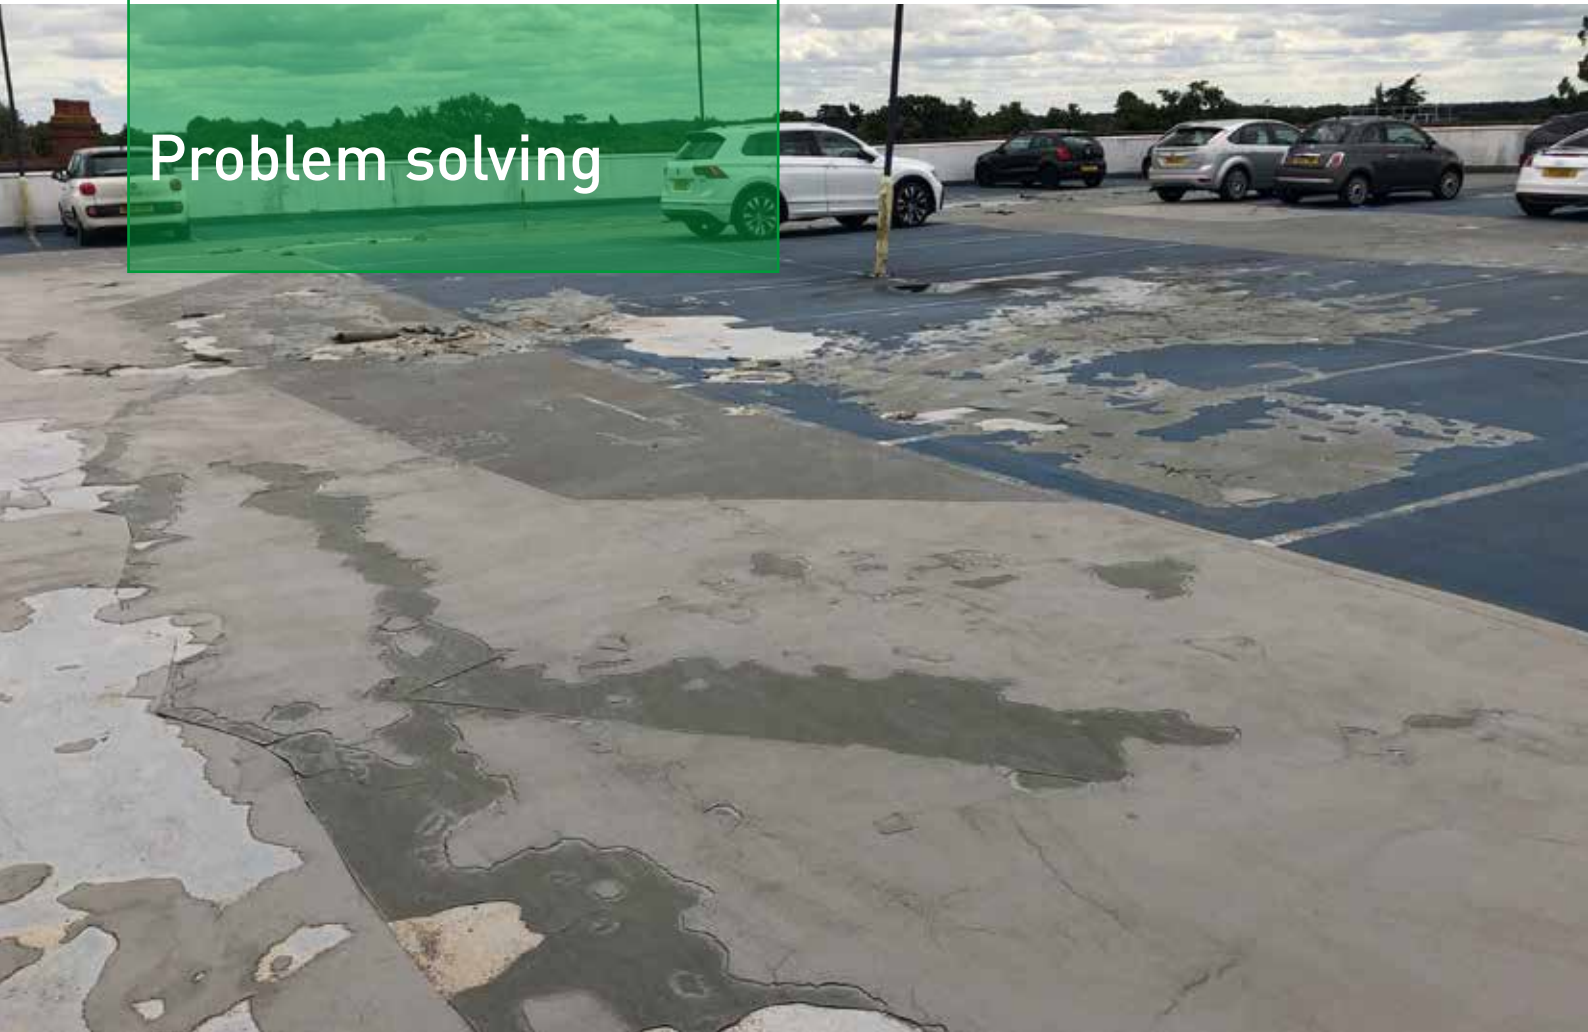
Before the installation of WestWood Liquid Technologies' **PMMA system**, defective concrete areas were reinstated using specialised repair mortars. Sacrificial anodes were added to reinforce longevity and **address ongoing corrosion concerns**. Trials were conducted using Westwood's primer to validate the bond to the existing and repaired concrete substrate, with results recorded by a calibrated Elcometer adhesion tester. Despite a strong bond, trials identified significant outgassing likely caused by moisture ingress through the existing failed coating.

Specialist captive blasting techniques were employed for preparation, followed by the application of Westwood's 821 **ultra-low viscosity** substrate stabiliser to seal the concrete slab, **eliminating the out-gassing issue**. Subsequently, WestWood Liquid Technologies certified OS 10-2.0 protection system comprising of Wecryl 279 waterproofing, Wecryl 333 wearing layer with quarts sand broadcast, and final coloured Wecryl 488 sealer coats were applied..
